A FORENSIC ANALYSIS OF RECLINER RELEASE VIA CONNECTING ROD IN REAR IMPACT AUTOMOTIVE COLLISIONS

Safety Analysis and Forensic Engineering (SAFE)

Paper Number 23-0327

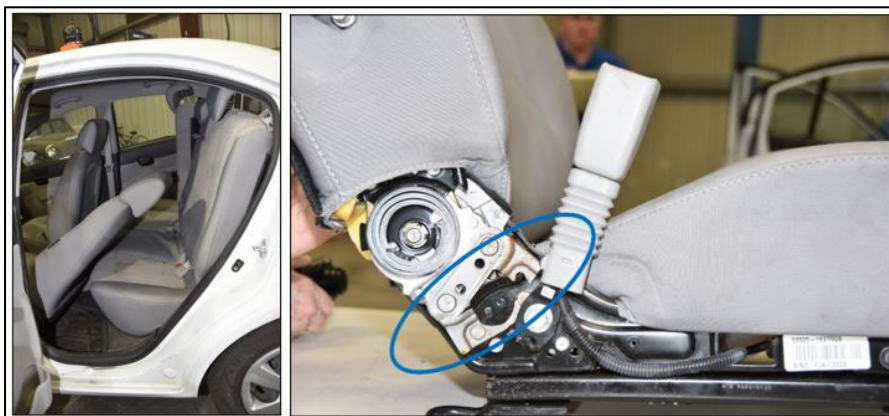
- The inboard lower recliner attachment to the seat base was torn (see Figure 3).
- The inboard lower recliner attachment and outboard lower recliner attachment were asymmetrically designed, with the inboard side having a hole in the middle (see Figure 4).
- The tear across the inboard lower recliner attachment allowed the inboard recliner to rotate rearward.
- The inboard and outboard recliners were found post-crash in different adjustment positions.
- Additionally, the recliners were disassembled to inspect the teeth of the pawls and sectors. The outboard sector gear teeth and pawls were found to be damaged.

Figure 3: Subject rear-ended vehicle seat with torn inboard lower recliner plate.

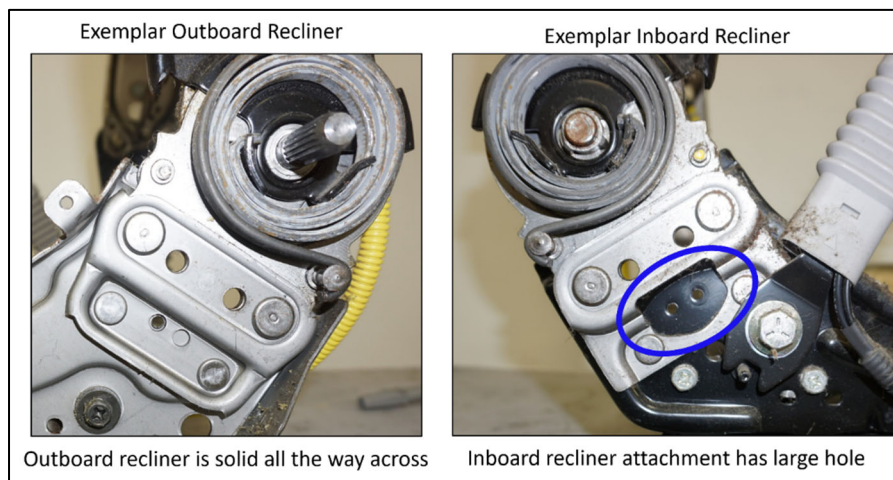
Figure 4: Exemplar seat with asymmetric lower recliner plate designs.

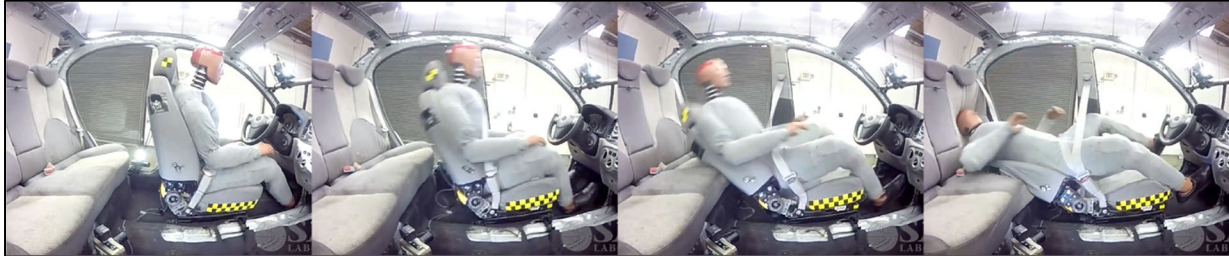
A sled test was performed by SAFE Laboratories of an exemplar seat in an exemplar test buck, with a modified 50th percentile Hybrid III Anthropomorphic Test Device (ATD) to match the seated height and weight of the driver of the rear impacted vehicle [5] [6]. The sled was subjected to an approximately 11.2 m/s (25 mph) rear delta-V, consistent with the accident reconstruction of the subject rear collision. The seatback was seen to rotate rearward in recline such that it failed to restrain the ATD, and the ATD made forceful head contact with the rear seat back (see Figure 5).

Figure 5: Sled test with ATD head contact at rear seat.

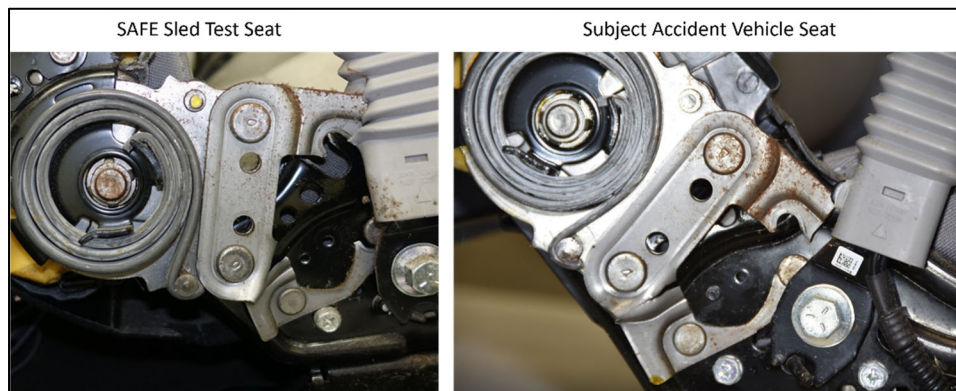
Further analysis of high-speed test video and inspection of the tested seat revealed the inboard lower recliner attachment plate tore similar to the accident seat (see Figure 6). The tearing occurred early in the seat loading phase of the test and caused the inboard recliner mechanism to rotate rearward. This rearward rotation of the inboard recliner also rotated the recliner connecting rod which in turn released the outboard recliner. This chain of events resulted in the failure of the seatback to provide any additional support to the ATD in the rear impact collision, and occupant containment was lost. The evidence identified on the test seat was found to be remarkably similar to the evidence identified on the subject accident seat. The posttest recliner inspection further revealed that the seat recliners became adjusted to different positions as a result of the release of the outboard recliner during the occupant loading event.

Figure 6: Sled test and accident vehicle seat comparison of inboard lower recliner attachment plates.

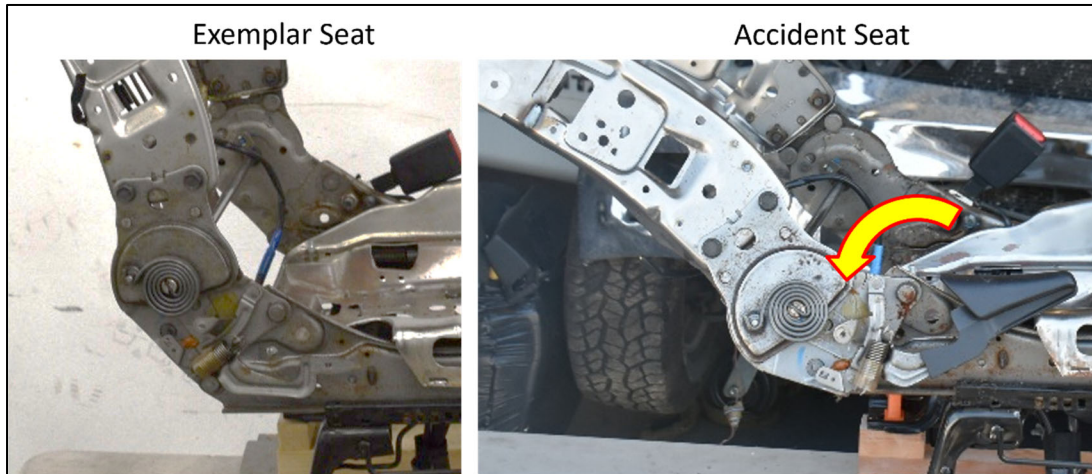
- The seat base and lower recliner attachment plate were deformed on the outboard side (see Figure 7), whereas the inboard side was relatively undeformed.
- The inboard recliner was found in a further rearward recliner adjustment than the outboard recliner (see Figure 8).

Figure 7: Deformation below outboard recliner.

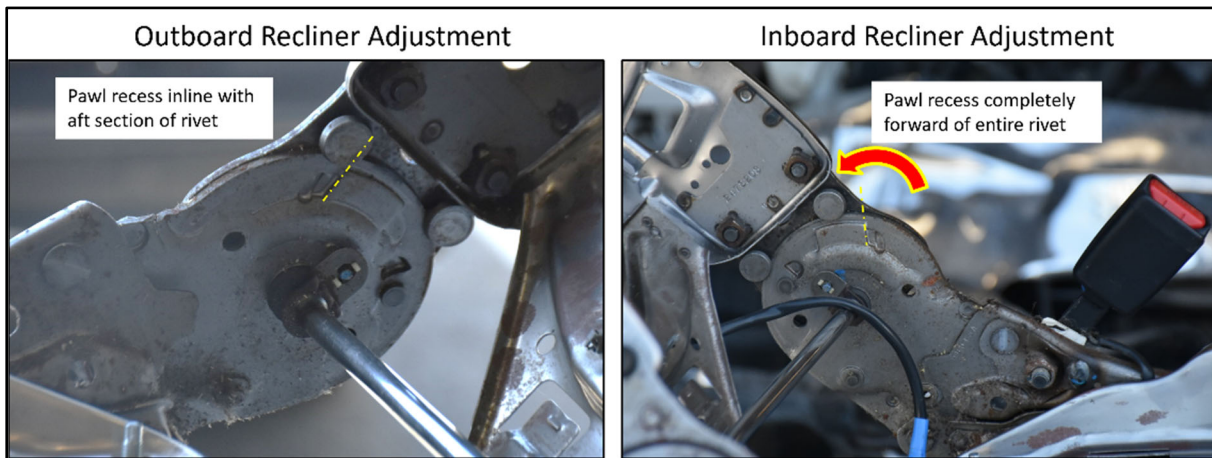
Figure 8: Inboard recliner adjusted further rearward than outboard recliner.

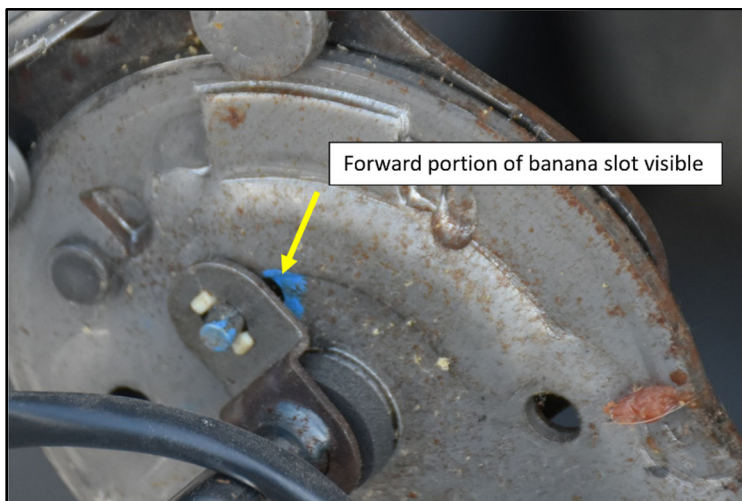
- The forward portion of the “banana slot” for the recliner release rod pin was visible on the inboard side, but not the outboard side (see Figure 9).

Figure 9: Forward portion of “banana slot” visible.

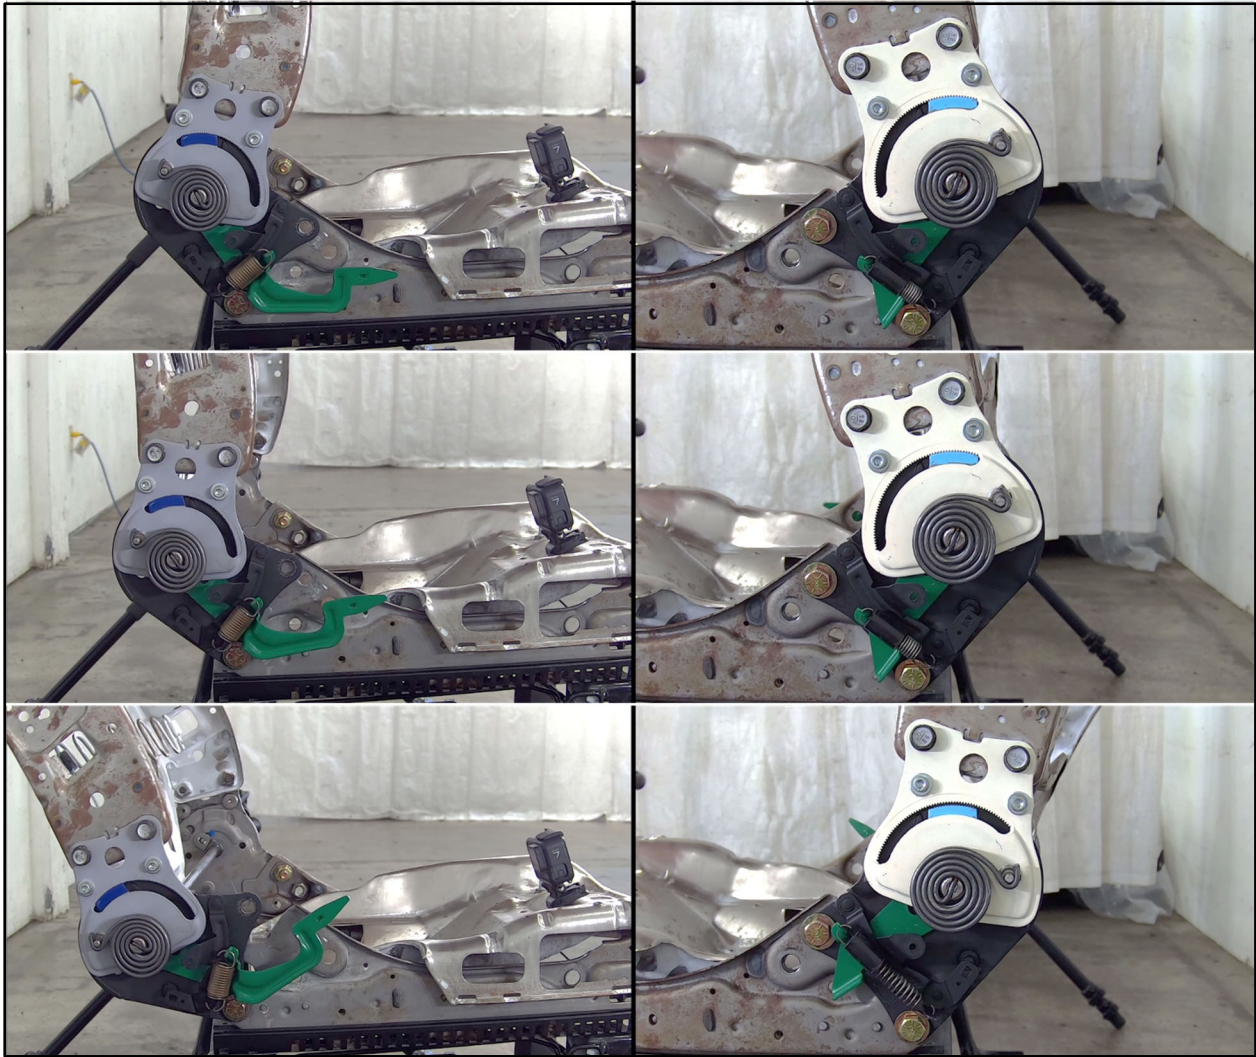
A demonstrative video was filmed to demonstrate this release mechanism. An exemplar seat was obtained and detrimmed. The recliners were disassembled and modified in order to view the internal pawls in relationship to the sector gears during the demonstration. The recliners were reattached to the seat, however, the lower front attachment was omitted, allowing the seat to experience a “deforming condition” for the demonstration. The “deforming condition” allowed for the outboard recliner to rotate rearward in relation to the inboard recliner, similar to the condition allowed by the outboard lower recliner support structure deformation seen in the accident seat. The top of the seatback was then loaded rearward and the inboard side recliner was seen to release by the rotating connecting rod (see Figure 10).

Figure 10: Video demonstration of recliner release via connecting rod.

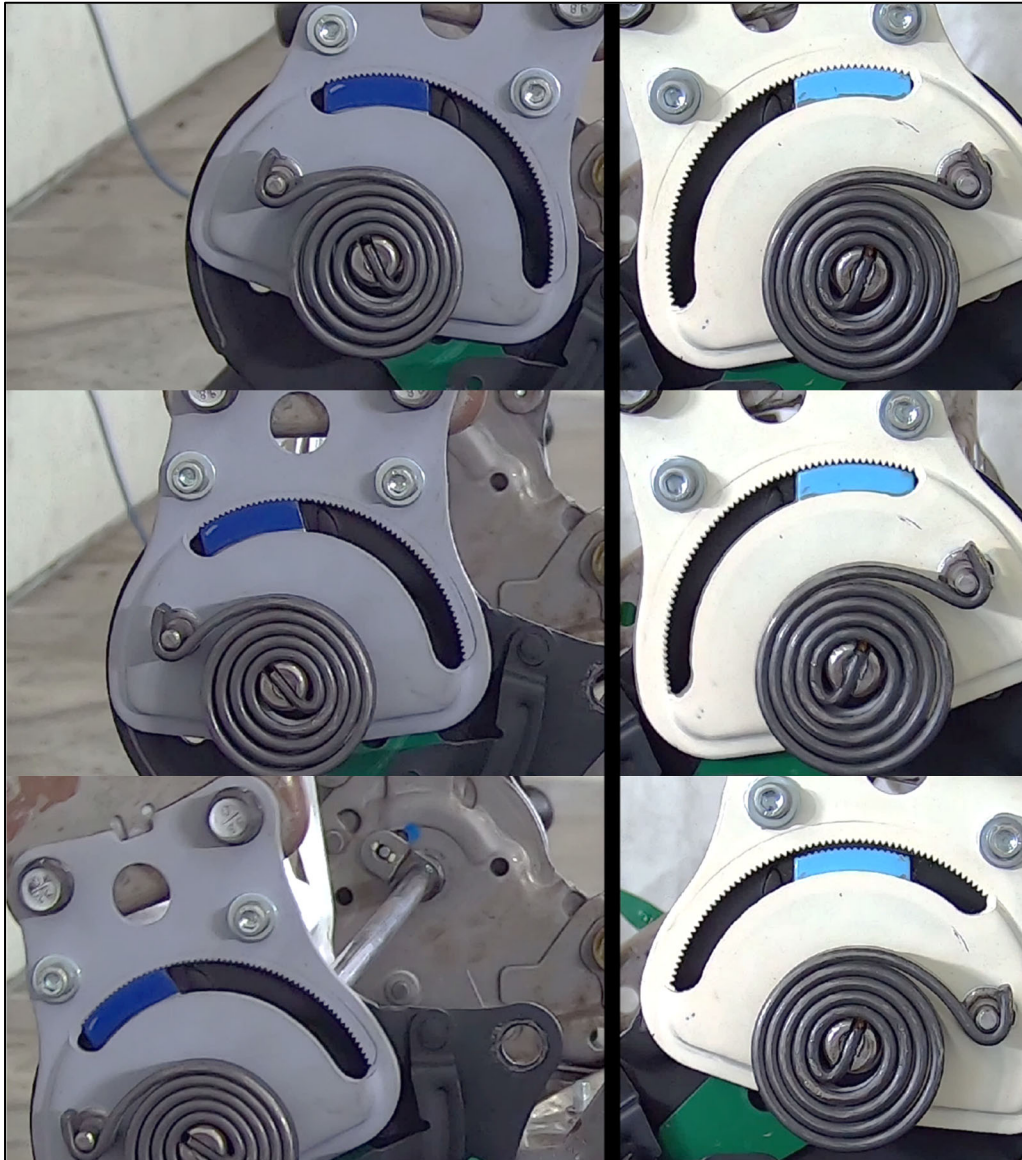
Analysis of the video demonstration shows that as the outboard side recliner itself rotates rearward, the recliner rotates the recliner connecting rod rearward along with it. As the recliner connecting rod rotates rearward, the inboard cam begins to rotate, and the inboard recliner releases (see Figure 11). At the end of the demonstration, the inboard recliner is found in a further rearward recline adjustment position than the outboard recliner, the front of the “banana slot” on the inboard side is visible, and the inboard recliner remains disengaged, even after load is removed, all consistent with the evidence found on the subject rear impacted vehicle.

Figure 11: Video demonstration zoomed in.

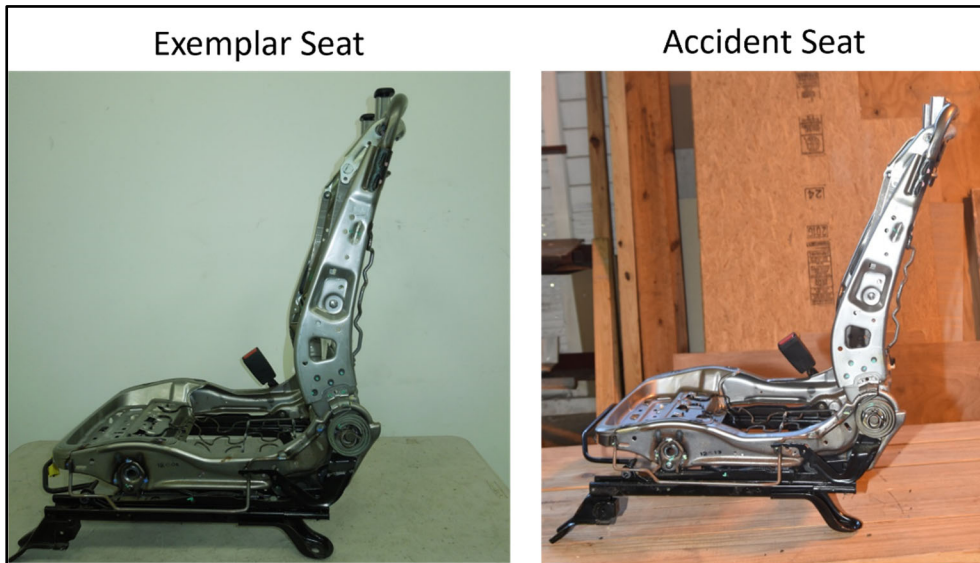
A post-crash analysis of the plastic deformation of the driver’s seat revealed very little static deformation when compared to an exemplar seat (see Figure 12). There was no gross asymmetrical tearing or deformation below the

Figure 12: Comparison of exemplar seat and accident seat – minimal deformation.

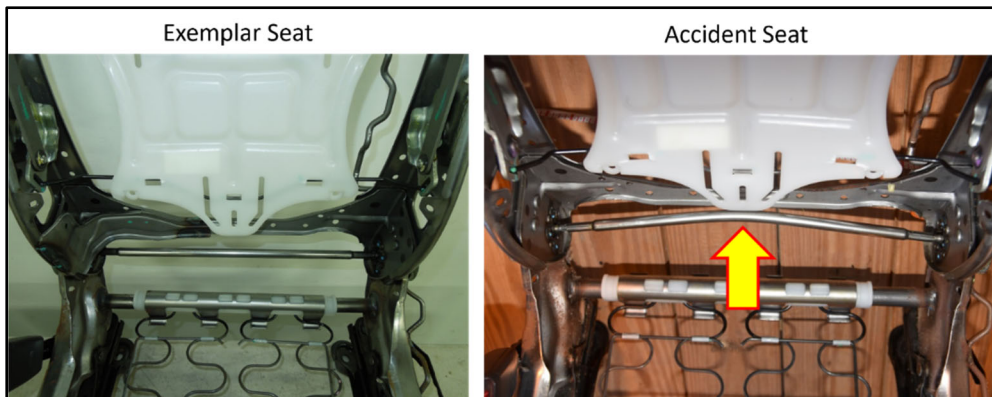
recliners as seen above in case 1 and case 2 however the recliner connecting rod was noted to be bent rearward (see Figure 13). This minimal deformation was inconsistent with the relatively high energy rear end collision as determined by the rear delta-V and occupant weight.

Figure 13: Comparison of exemplar seat and accident seat – recliner connecting rod deformation.

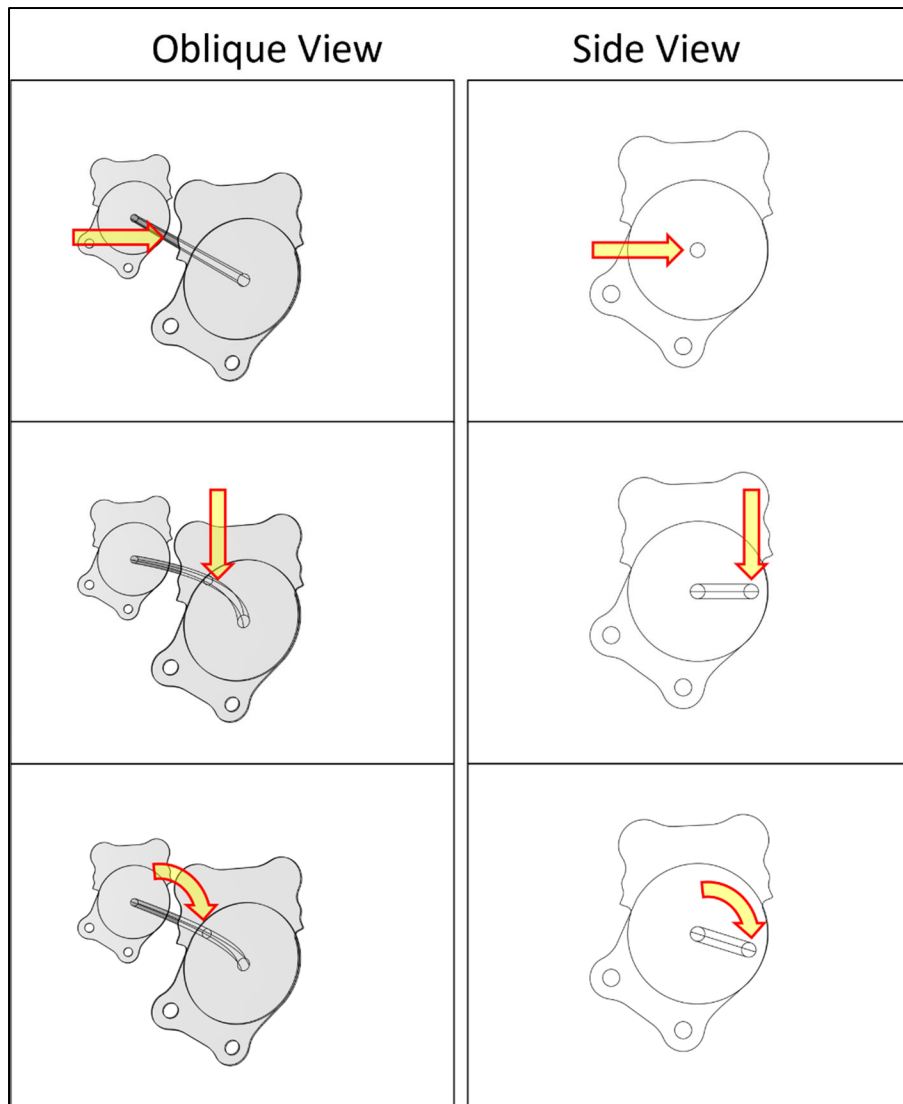
A Failure Mode and Effect Analysis (FMEA) concluded that the occupant's buttocks / lower torso had loaded the recliner connecting rod rearward and then downward, such that it could create a moment on the connecting rod and rotate it sufficiently far to release the recliners during the early phase of the rearward occupant loading the seat (see Figure 14).

Figure 14: Recliner release mechanism from occupant loading of recliner connecting rod.

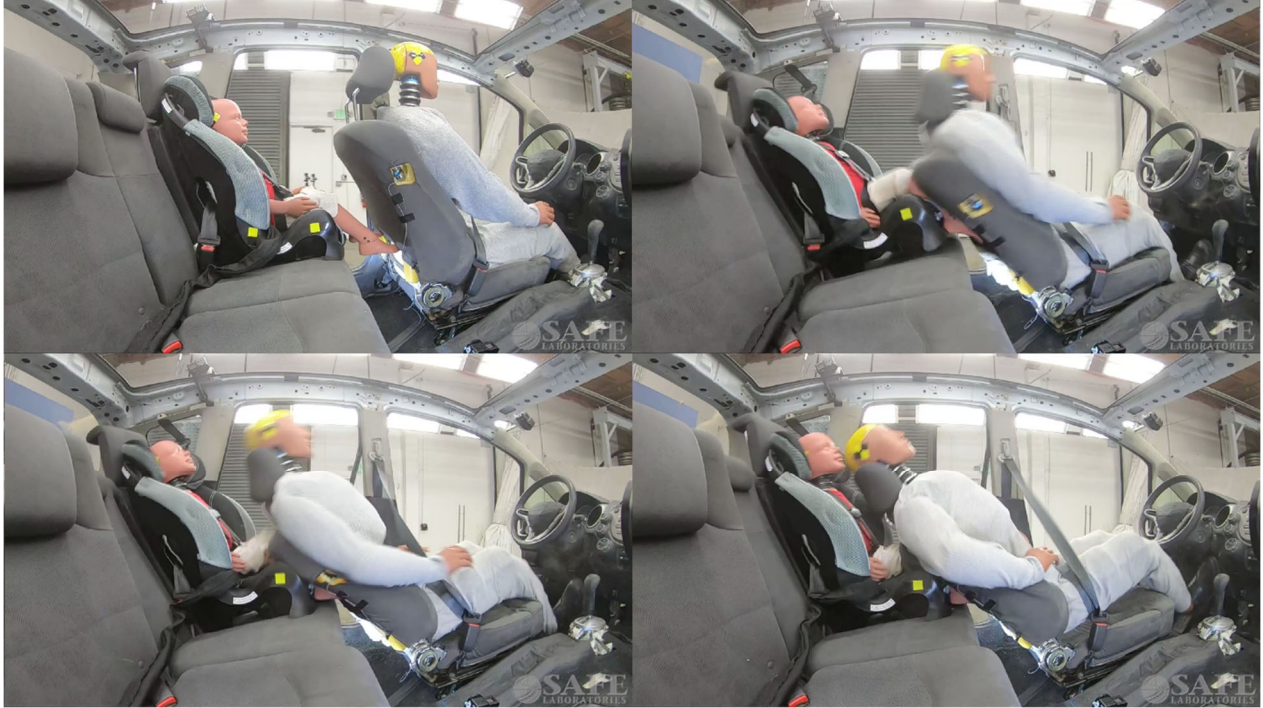
In sled test #1, the driver's seat recliners both remained engaged and transferred load into the seat structure such that the seat structure yielded rearward as the occupant loaded the seatback and moved towards the 3-year-old ATD. The seat contained the driver ATD and injurious head contact to the 3-year-old was avoided (see Figure 15). The seat statically deformed rearward in recline approximately 19 to 20 degrees (approximately 15 degrees more than the subject seat) (see Figure 16).

Figure 15: Sled test #1 occupant kinematics – no head-to-head contact.

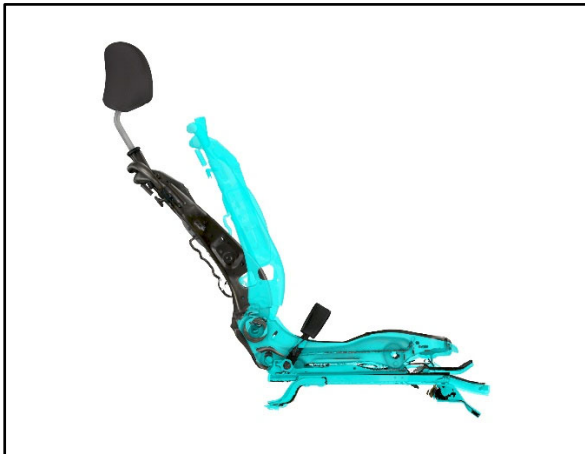
Figure 16: Sled test #1 seat deformation.

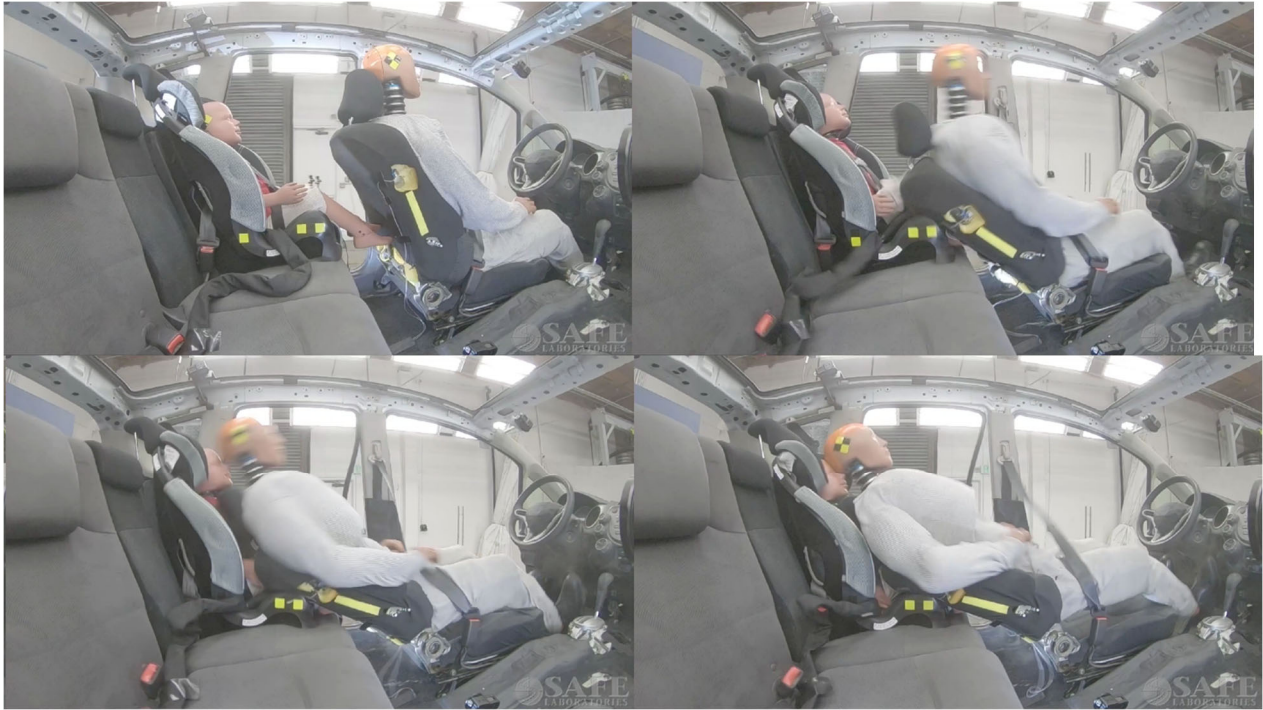
In sled test #2, the seatback was seen to rotate rearward in recline without transferring occupant load into the seat structure to provide crash energy absorption, occupant ride down, and occupant restraint. The driver ATD was seen to move rearward relative to the occupant compartment and made heavy head to head contact with the anterior of the 3-year-old ATD head seated in the child seat (see Figure 17). Posttest analysis showed the seat in test #2 was minimally deformed (similar to and consistent with the evidence seen in the subject seat) due to the recliners being disengaged throughout the entire occupant loading phase (see Figure 18).

Figure 17: Sled test #2 occupant kinematics – heavy head to head contact.

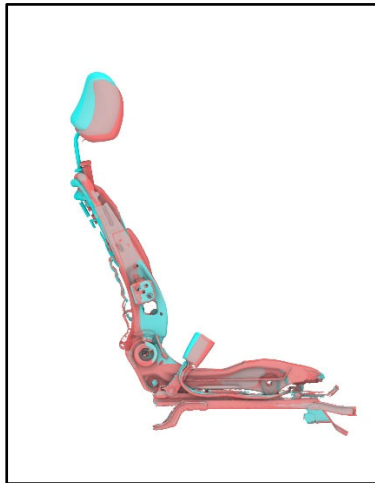
Figure 18: Sled test #2 seat deformation – minimal deformation.
