A FORENSIC ANALYSIS OF RECLINER RELEASE VIA CONNECTING ROD IN REAR IMPACT AUTOMOTIVE COLLISIONS

Safety Analysis and Forensic Engineering (SAFE)

Paper Number 23-0327

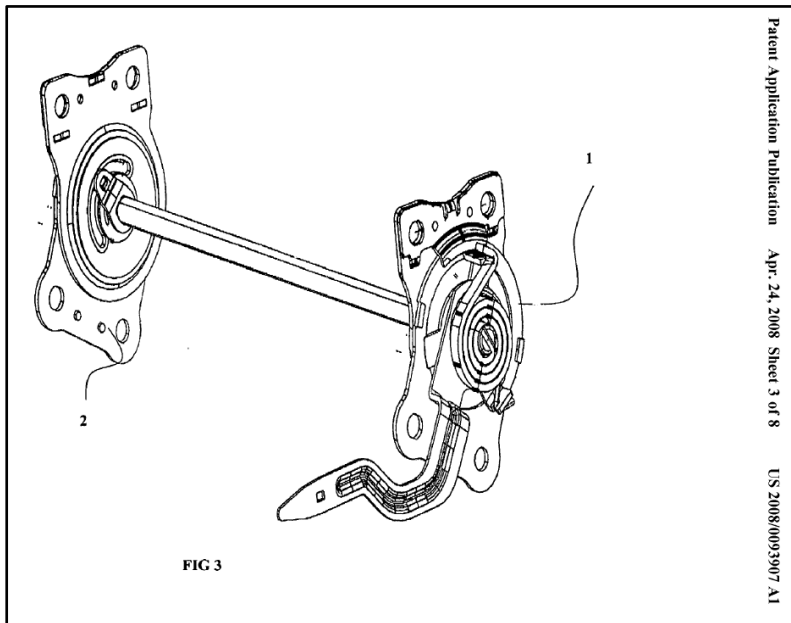
A typical design for dual manual recliner seats contains two pawl and sector recliners controlled by a cam in each recliner. The two cams are connected via a recliner connecting rod, and the recliner adjustment handle is connected to the recliner connecting rod itself, or controls one of the cams (see Figure 1). As the recliner handle is pulled up by the user, the outboard cam rotates while the recliner connecting rod rotates the cam in the second recliner at the same time. The rotation of the cams allow the pawls to disengage from the sectors, releasing the recliners, and the

Figure 1: Drawing of dual recliner system with pawl and sector gears and connecting rod [4].

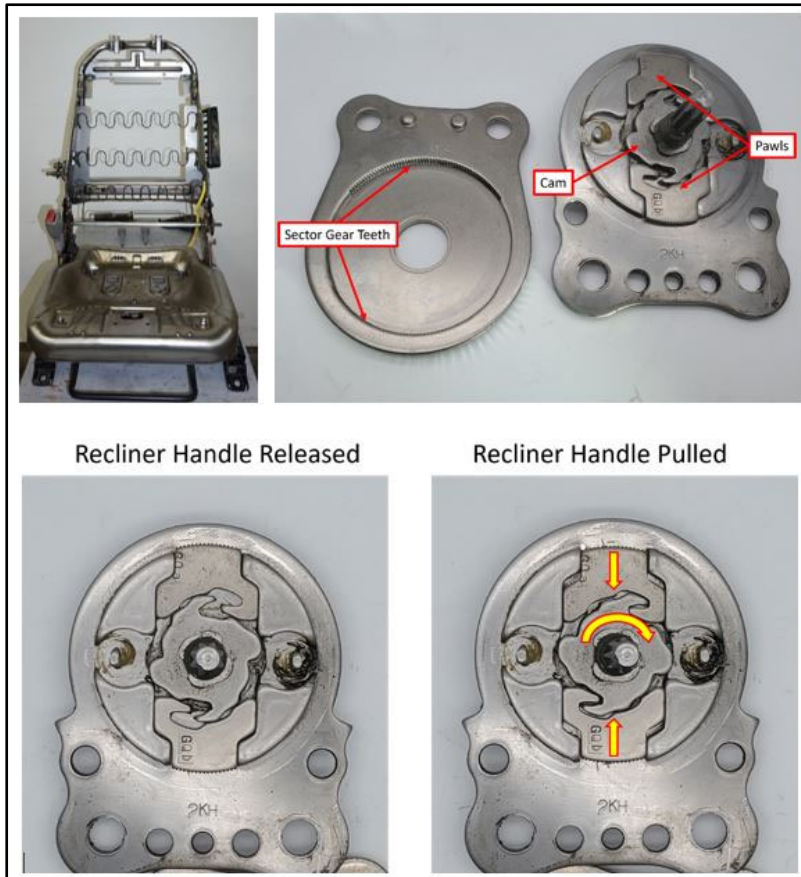
seat back is then able to be adjusted in recline (see Figure 2). As the user releases the spring loaded handle, the cams are both rotated back, pushing the pawl teeth back towards the sector teeth to re-engage both recliners and prevent further movement of the seatback at the recliners.

Figure 2: Typical dual manual recliner seat with pawl and sector recliners.
