Are there Differences in Wear Modes, Debris Type, and Tissue Response between Anatomic and Reverse Shoulder Arthroplasties?

Deborah J Hall¹, Stanley Liu, Niraj V Lawande, Gregory P Nicholson², Grant E Garrigues³, Robin Pourzal⁴

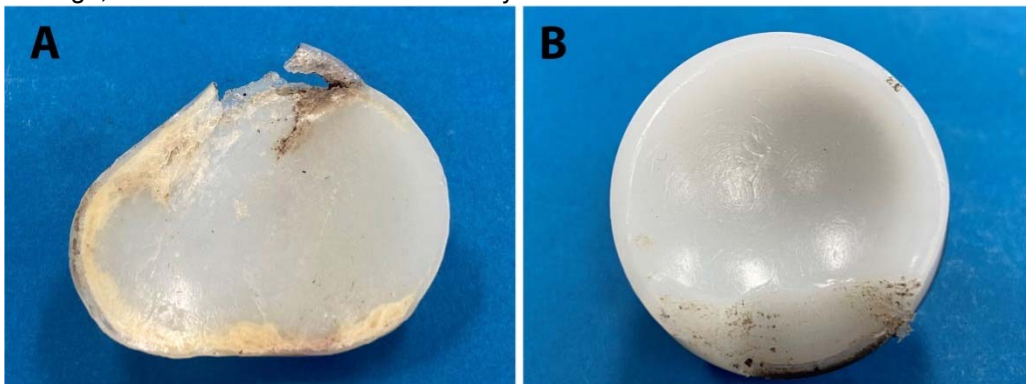
Figure 1A: Severely delaminated aTSA glenoid component with extreme wear-through at rim; B: Excessive rim damage in a rTSA component due to scapular notching which occurs when the PE of the humeral component is in repetitive contact with the inferior scapular neck.

RESULTS: PE bearing surface scores were greater in the aTSA group (8.6 ± 2.4 , 4.8 ± 1.7 , $p \leq 0.000$). The PE bearing surfaces of aTSAs were dominated by 3-body wear and plastic deformation, whereas the rTSA PE components exhibited mainly polishing and scratching. Cases with severe rim damage occurred mainly due to delamination and plastic deformation in aTSA, and in rTSA due to notching (8 of 28 cases) (Figure 1). Metal surface damage occurred in a few cases in both groups. Only one aTSA case exhibited marked taper corrosion. Metal particles were seen in 77% of aTSAs and 93% of rTSAs. More bone cement and suture debris was seen in the aTSA group compared to the rTSA ($p \leq 0.004$). In both groups the primary nature of the inflammatory response was a moderate to marked macrophage response to wear particles (86% of cases). The particle-laden macrophages tended to occur in broad sheets and contained metal, PE, bone cement, and suture debris. There was no difference in the cellular response between aTSA and rTSA.
