# Metal Release from Spinal Instrumentation Implants - Synchrotron-Based Multi-Element Detection in Human Peri-Implant Tissues

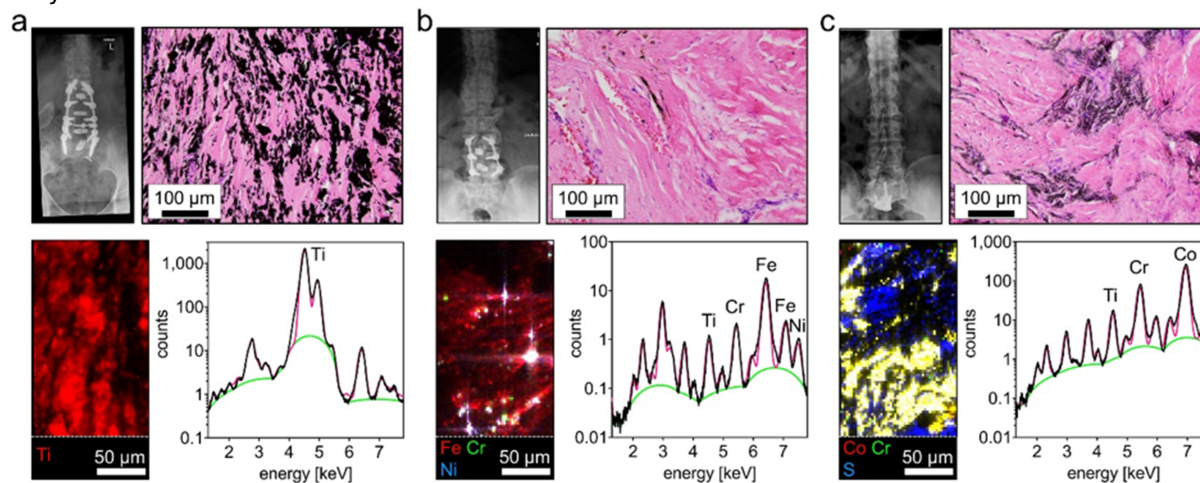
**Figure 1** | Synchrotron-based XRF analyses revealed multi-metal exposure in tissues adjacent to spinal implants. (a) Substantial titanium exposure in S1 left-sided, "peri-screw-head" tissue. (b) Co-localized iron-, chromium-, nickel-containing particles (steel) in soft tissue from around a loosened screw. (c) Co-localized cobalt and chromium within tissue from intervertebral disc space L5/S1.

The spatially-resolved multi-element detection in peri-implant tissue sections revealed exposure to titanium, steel (FeCrNi), and CoCr (Figure 1). Titanium exposure was particularly found in soft tissue samples from around pedicle screw heads, loosened screws, broken screws, and from within the screw channel. Steel particles were detected in soft tissue specimens excised from loosened screws, a broken rod, and in one case from interspinous soft tissue. CoCr exposure was found in one soft tissue specimen excised from the intervertebral disc space.
