## A novel technique for arthroscopic outside-in meniscus repair using a newly designed needle JUN BAE KIM<sup>1</sup>

<sup>1</sup>Seoul NOW Hospital

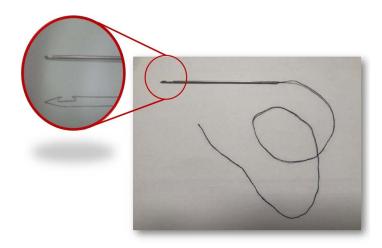
Unique design of new needle allows sutures to be handled both anterograde and retrograde through tissue. Therefore, complex tools such as shuttle relay and grasper are no longer needed. Suture is possible with just one needle and any kind of thread (PDS, Ethibond and Fiberwire) preferred by operator can be used.

New needle has several advantges: 1)Time saving 2)Low profile needle (1.0 ~ 1.2 mm) 3) Single needle allows better use of the working space 4) Reduce possibility of iatrogenic injury to cartilage 5) Can make vertical suture easily. It can be used in various types of meniscus surgery: 1) Vertical, peripheral tear of AH of MM,LM 2) MM or LM Bucket handle tear 3) MAT (Meniscal allograft transplantation). Not only for meniscus, it also can be applied for other arthroscopic surgery including wrist (TFCC injury), elbow, ankle, shoulder and so on.
